Waiapu Cathedral of St. John the Evangelist, Napier

Detailed Seismic Assessment

7 December 2021

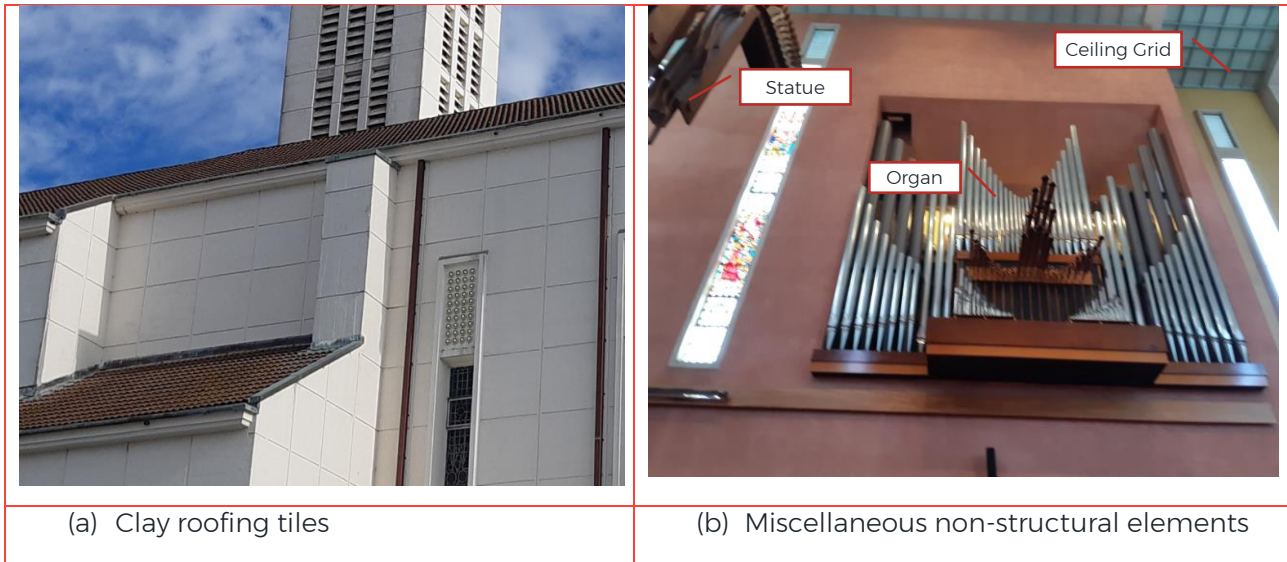
Figure 3: Non-structural elements

The roof above the Nave and Chancel is provided with clay tiles that are supported on timber framing. The average height of these tiles is approximately 17m above the Nave floor level. If not properly connected to the roofing grid and the structure framing these heavy clay tiles may displace and could result in life safety issue.

Ceiling grids are suspended below the sloped roofs beams in the Chancel and Chapel. Ceiling grids are suspended between the sloped beams in the Nave. The ceiling grid is constructed of timber framing and lacks seismic restraint to the structural roof beams.

There are several elements including organs and statues around the cathedral building placed at heights and the restraints of these elements would require proper assessment.

There is limited information available on the details of the connection between the base of the cross and the tower roof slab.

The safety of the occupants may be affected if heavy items are not adequately secured and properly restrained. We have not assessed these non-structural items in our DSA, however, we do suggest providing proper restraint to the elements we have identified below and the likes of those.
